DYED WATER TESTING PROCEDURES OUTFALL SEWERSHED BALTIMORE CITY PROJECT 1039

BALTIMORE OUTFALL SEWERSHED DYED WATER TESTING PROCEDURES PROJECT 1039 TABLE OF CONTENTS

REI DRAYCO SEPTEMBER 3, 2009 CITY OF BALTIMORE OUTFALL SEWERSHED LOCATIONS TO BE DYE TESTED PROJECT: 134268

Microsoft Access Database Users Guide and Administrator's Manual

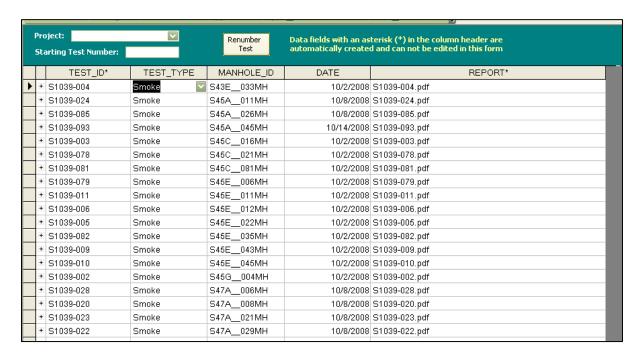
Figure 1 - Main Database User Form

When the database is opened, the main user form is automatically displayed as shown in Error! Reference source not found. The form lists all the currently stored smoke and dyed water tests in the database.

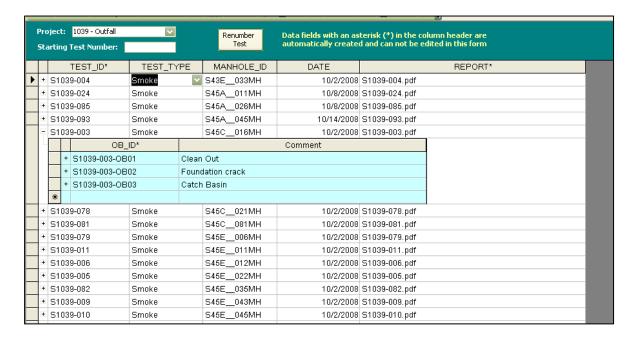
Figure 2 - Observation Records

Clicking the small plus sign on the left side of the TEST record will open a subdatasheet showing all observations for the specific test selected, as shown in Figure 2.

Note: The Comment field is the only user-editable field in the Observation subdatasheet.

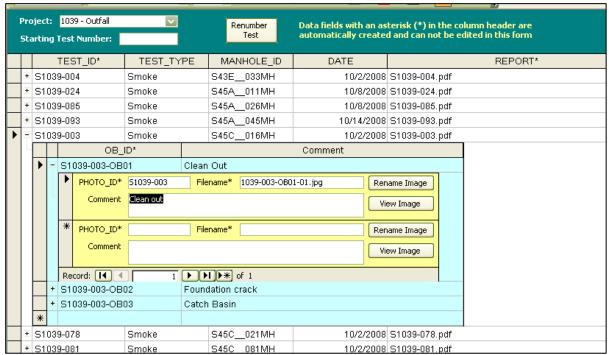
Figure 3 - Observation Photo Form

Clicking the small plus sign on the left side of the Observation record will open a subform showing all photos for the observation selected, as shown in the figure below.

Note: The Comment field is the only user-editable field in the Photo subform.

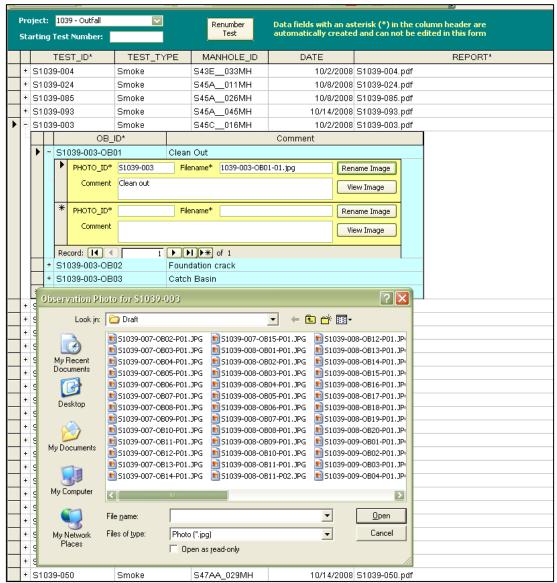
Figure 4 - Selecting an Image File to Rename

The Rename Image button can be used to rename photo files to the proper filename as defined in the BaSES specifications. When this button is clicked, a file browser dialog is displayed allowing the user to select the specific image file associated with this observation photo record as shown in Figure 4. Once an image file is selected, the application will properly rename the file so that it is properly linked to the observation photo record.

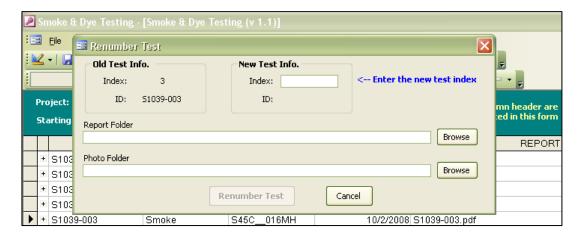
Figure 5 - Renumber Test Form

Select a test to renumber and press the Renumber Test button. The application will display the Renumber Test form as shown in Figure 5. The old test index and ID are display in the upper left corner of the form. You can enter a new index value to be used to create a new test ID.

If the Report Folder and Photo Folder are not populated, press the Browse button and select the folder in which the report or photo files exist. If these folder fields are properly set, the application will automatically rename the external report and observation files associated with the renumbered test.
